# 特定災害復旧事業「稲舟地区」 令和7年度 実施予定工事の概要

令和7年7月14日

農林水産省 北陸農政局

土地改良技術事務所

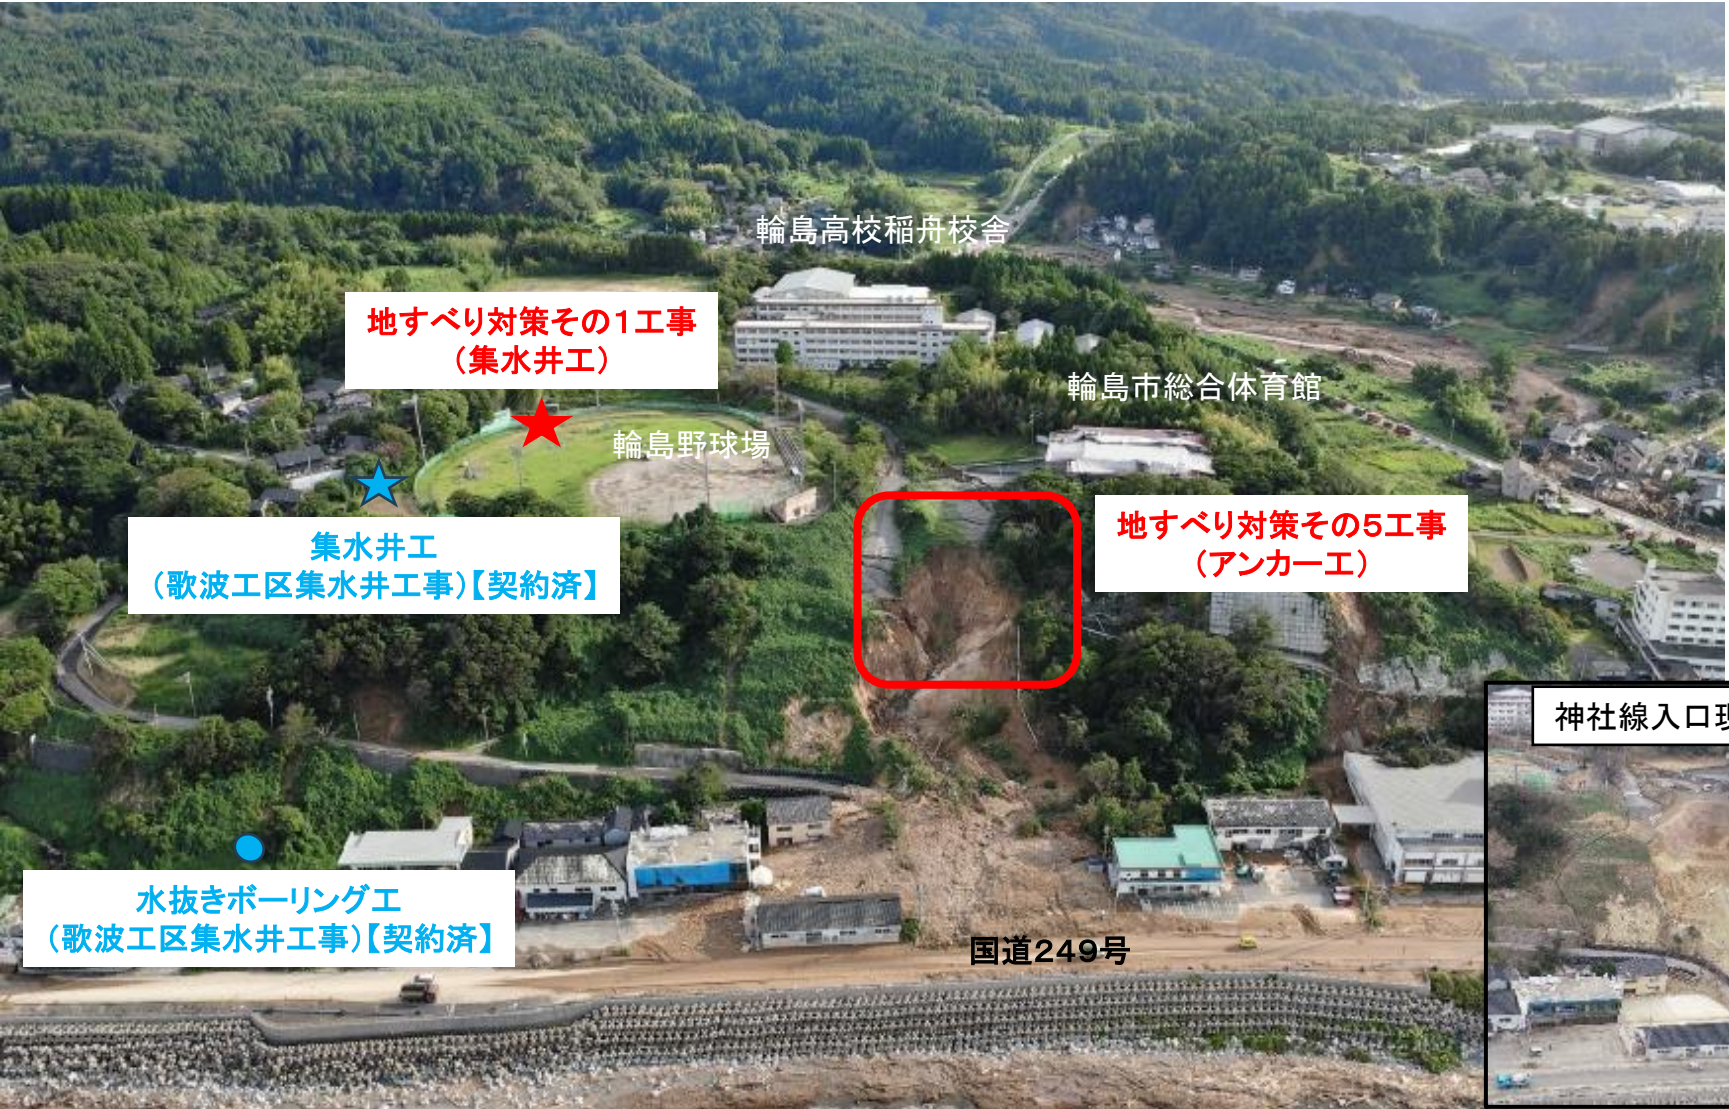
## (1) 稲舟地区 対策工 (西側)

凡例 ★● 実施中  
★□ 今年度工事予定

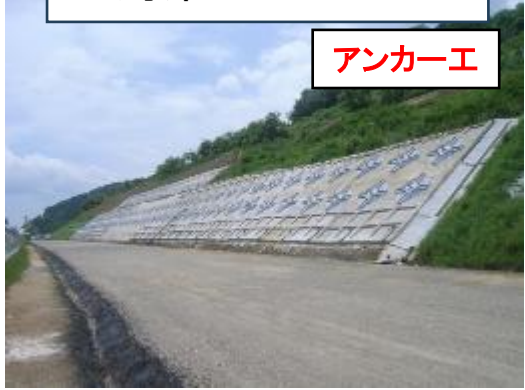
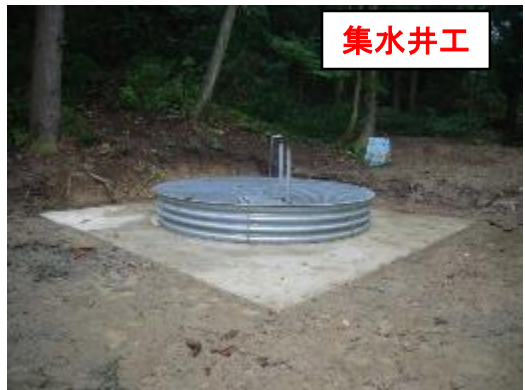
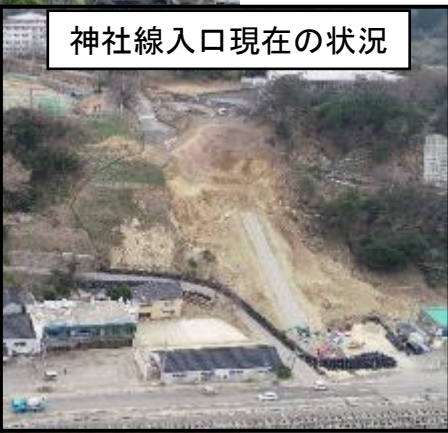
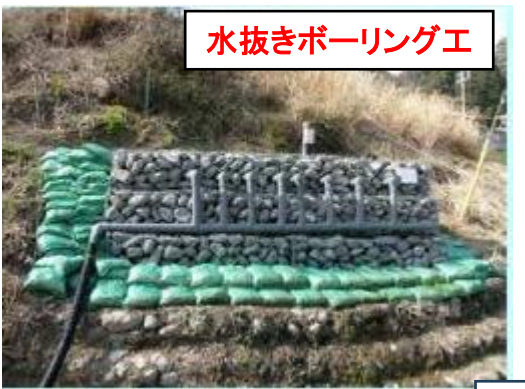
## 対策工イメージ

アンカー工

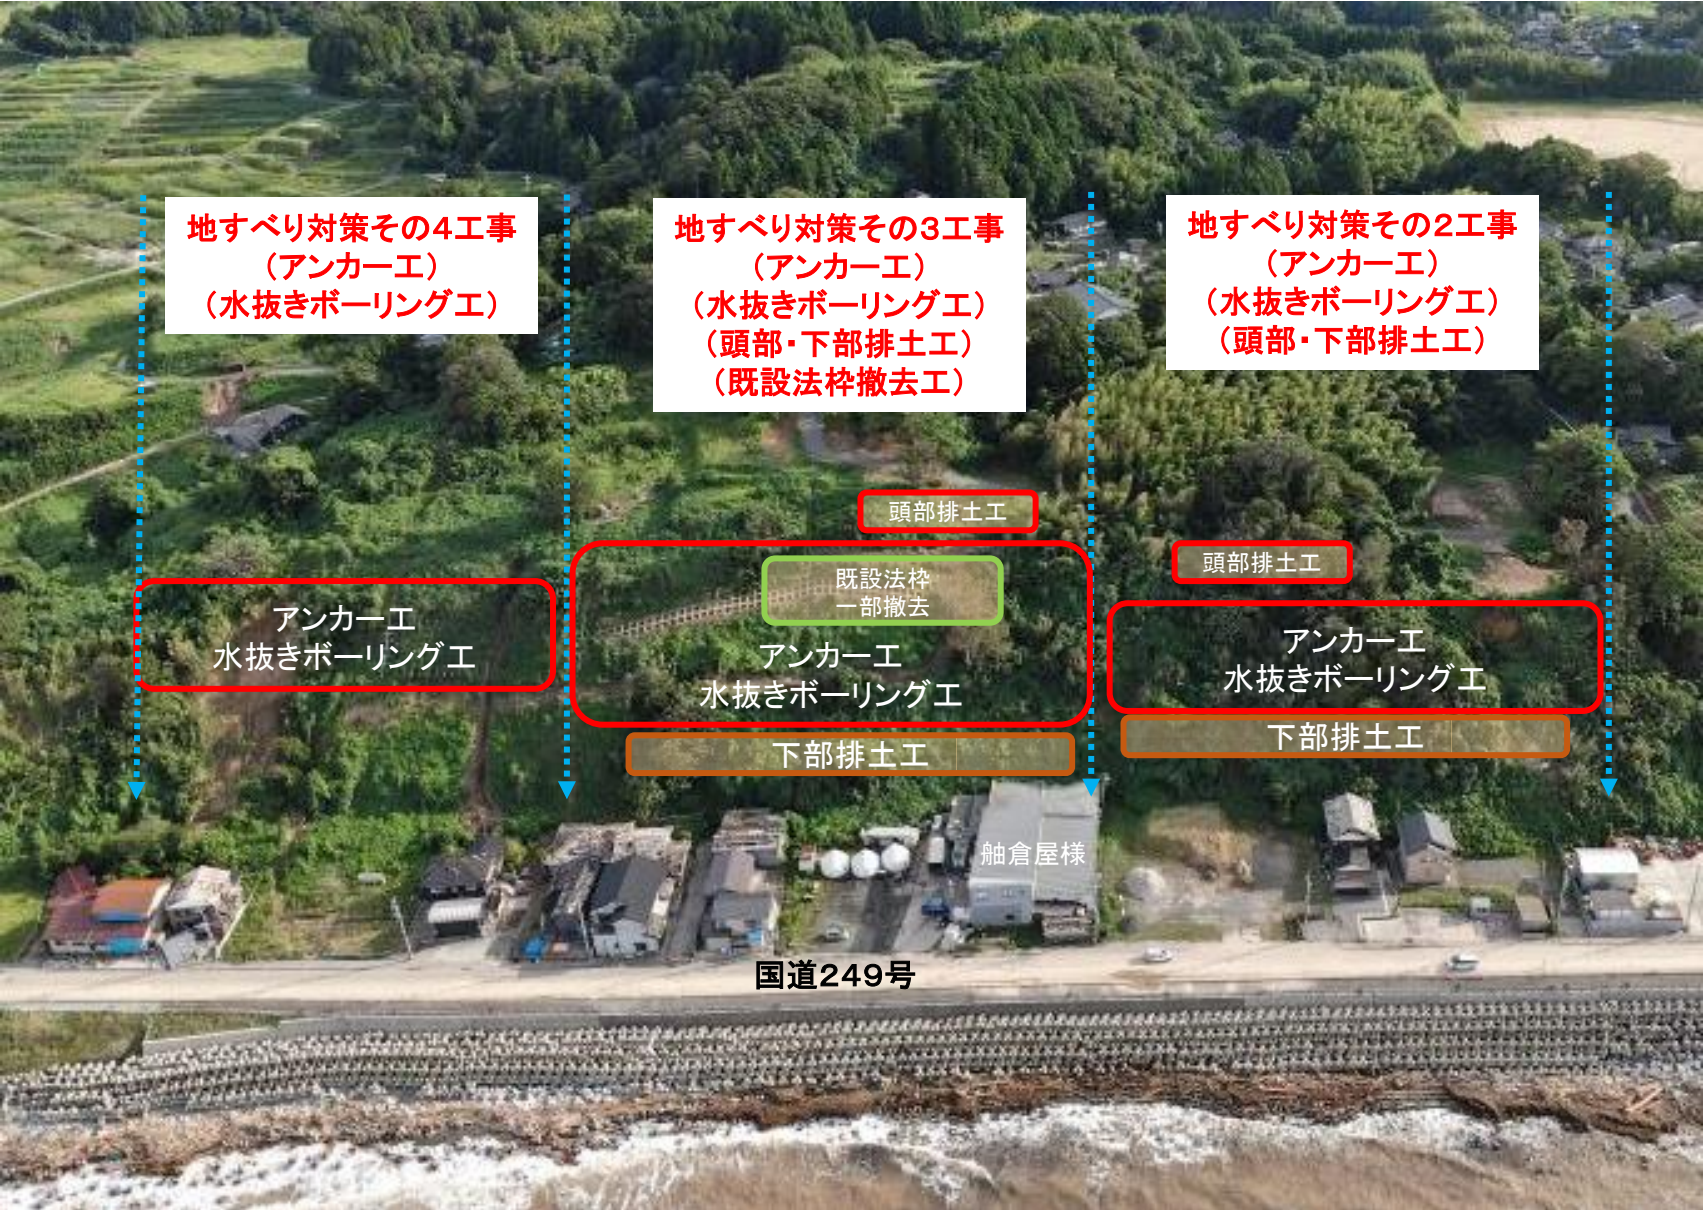
(2) 稲舟地区 対策工 (中央部)

凡例   今年度工事予定

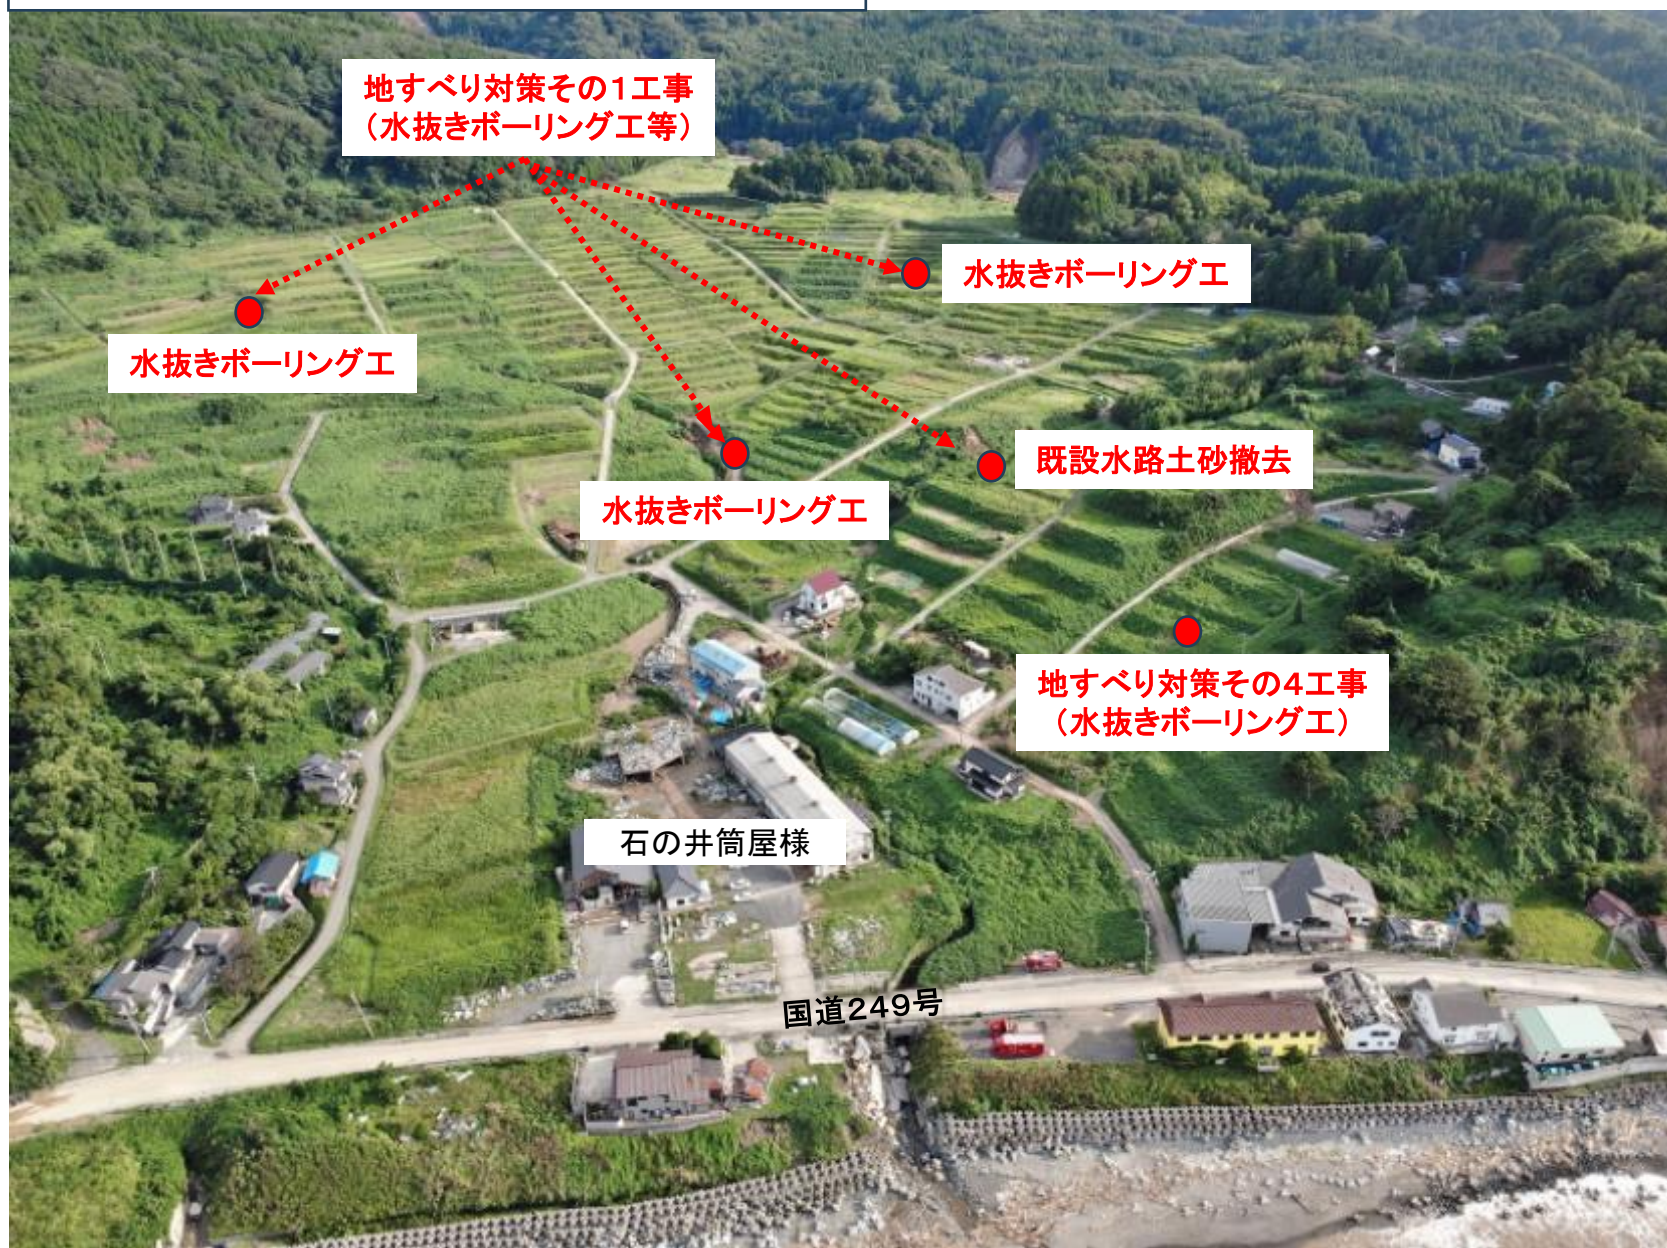
### (3) 稲舟地区 対策工 (東側)

凡例 ● 今年度工事予定

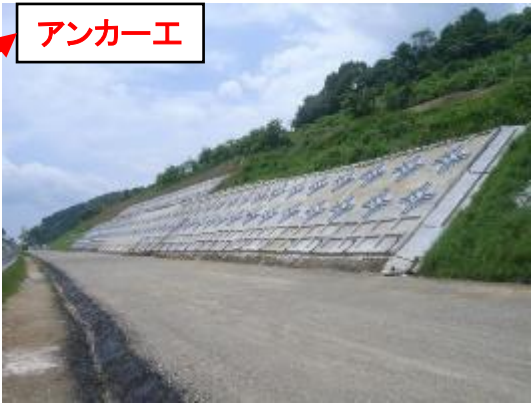
頭部排土工/下部排土工

斜面頭部の亀裂等により不安定となっている箇所や斜面下方の土砂押し出し及び崩落箇所の土砂を取り除きます。

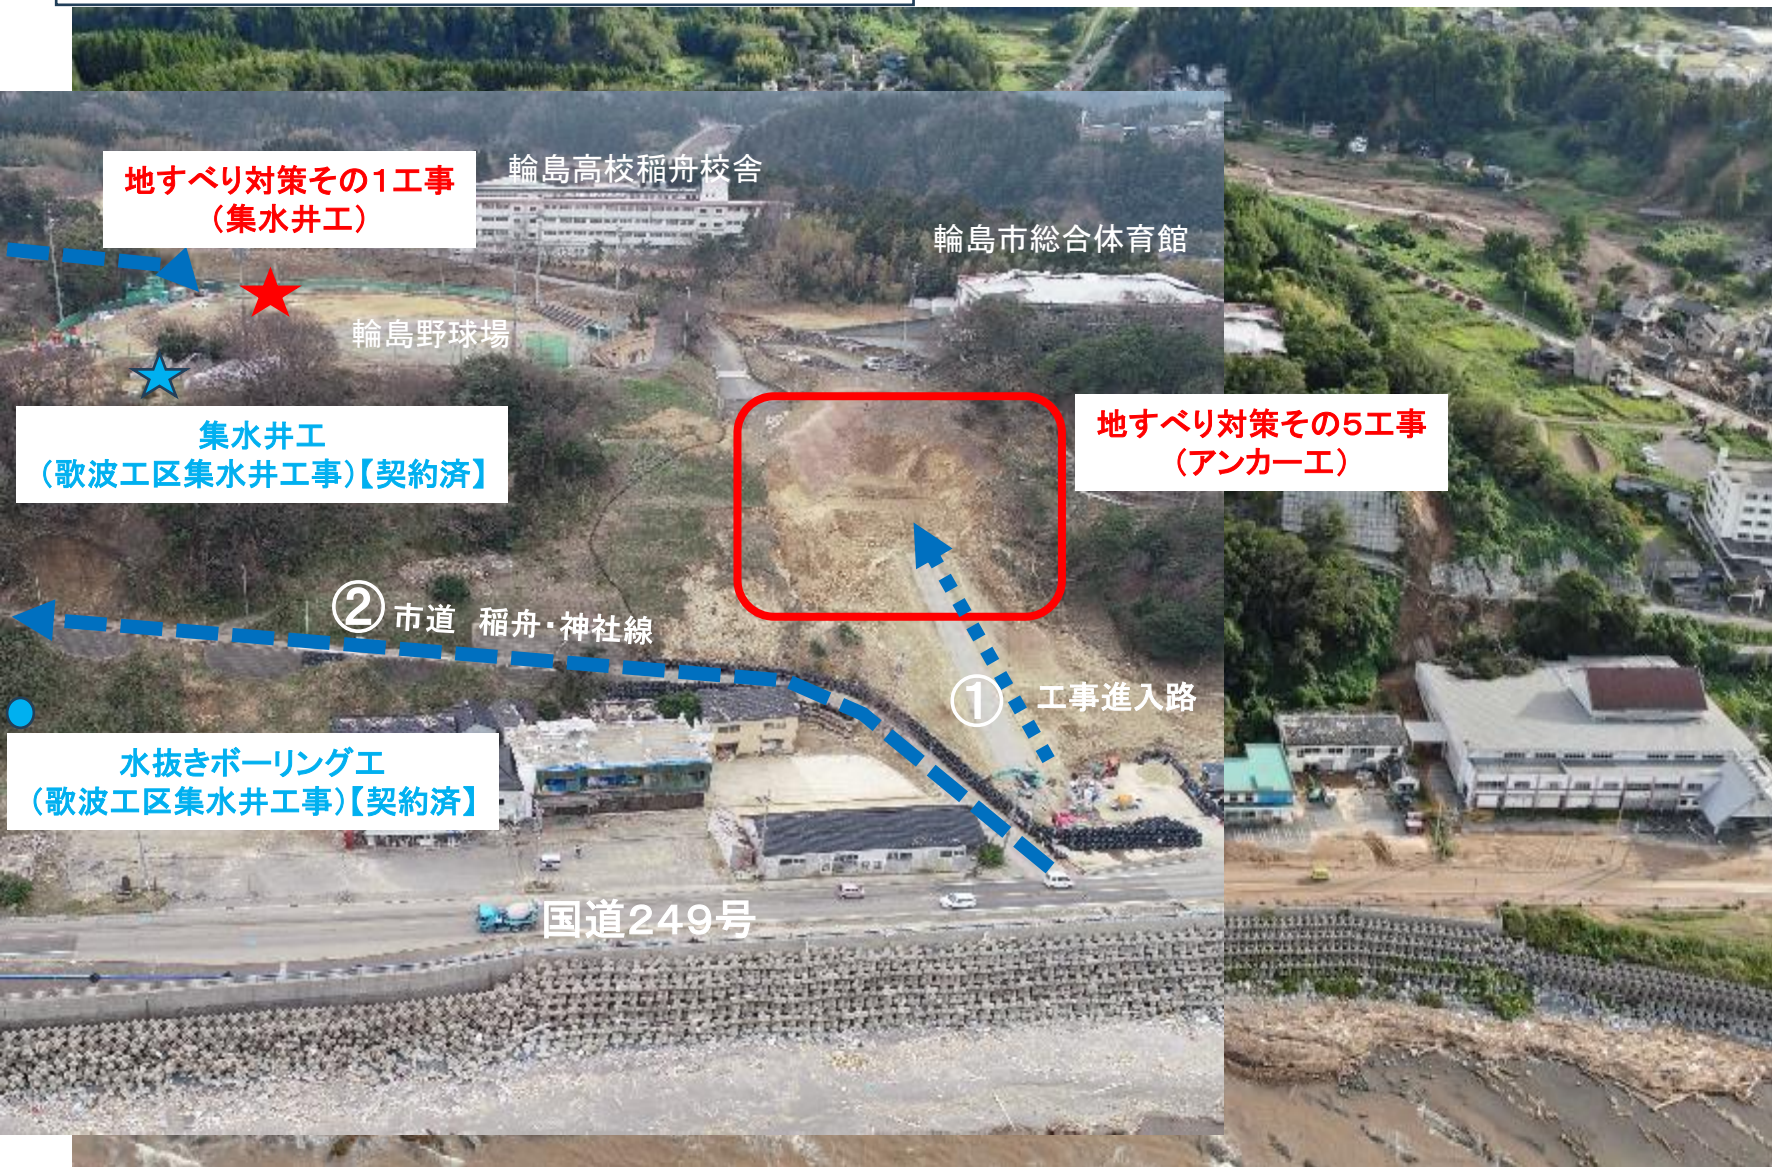
工事車両の進入路 (西側)

..... 工事進入路

①アンカー工は、崩壊斜面に造成した進入路を使用

②集水井工は、市道稲舟・神社線を利用

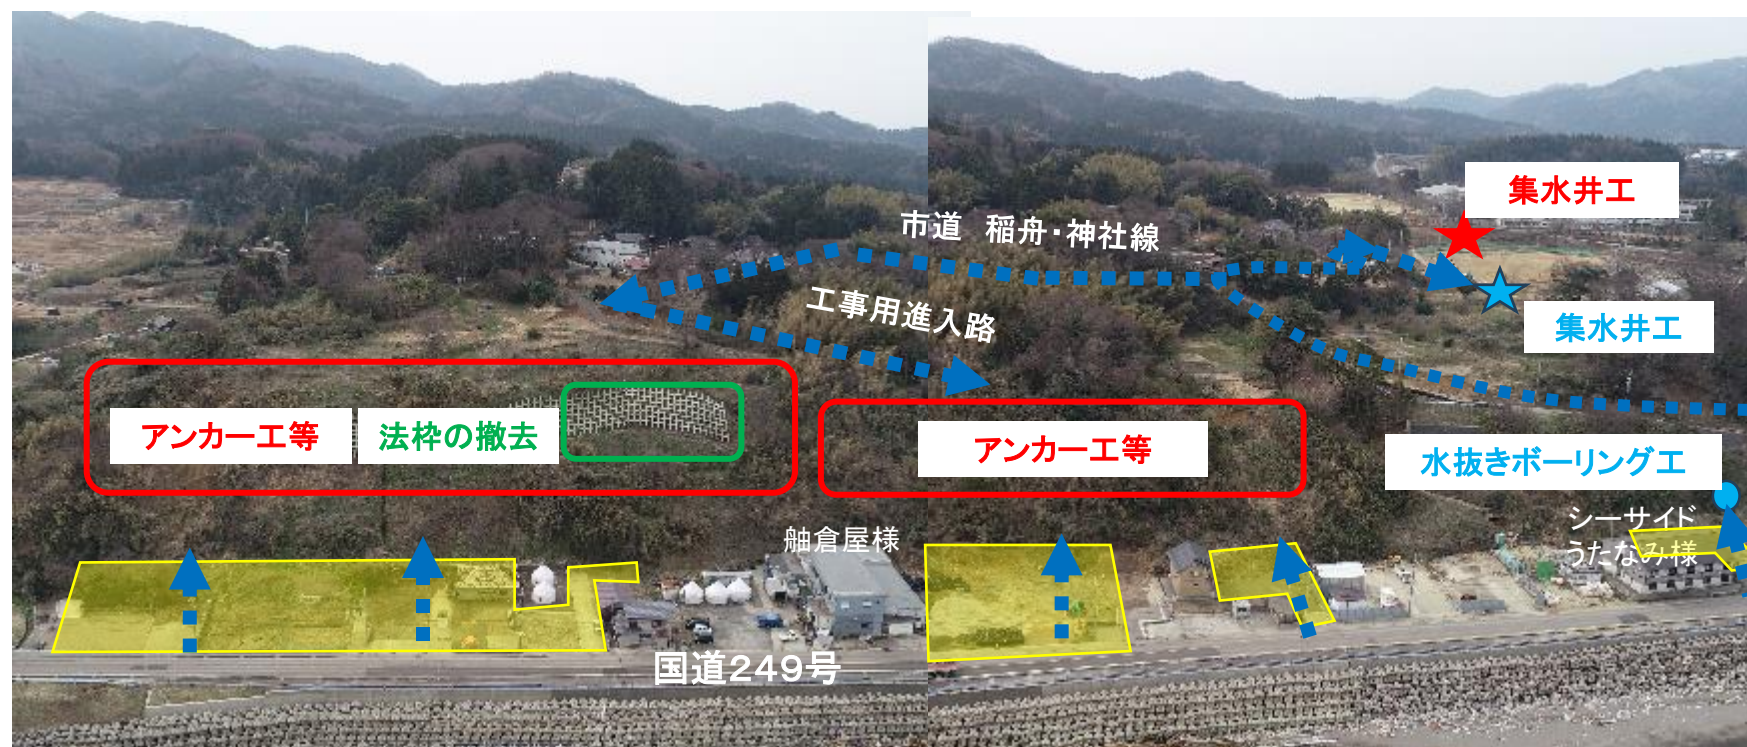
## 工事車両の搬入ルート等（中央部）

- ・国道沿いの斜面对策工は、仮設ヤードを設けて資機材を搬入
- ・斜面頭部は、昨年造成した工事用進入路を利用

..... 工事進入路  
■ 仮設ヤード

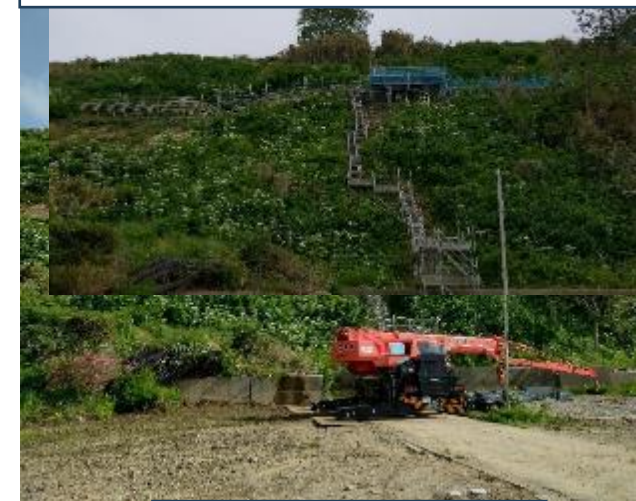
【仮設ヤード】  
工事用資材の大型クレーン  
による荷上げ作業に使用

※写真は施工イメージ

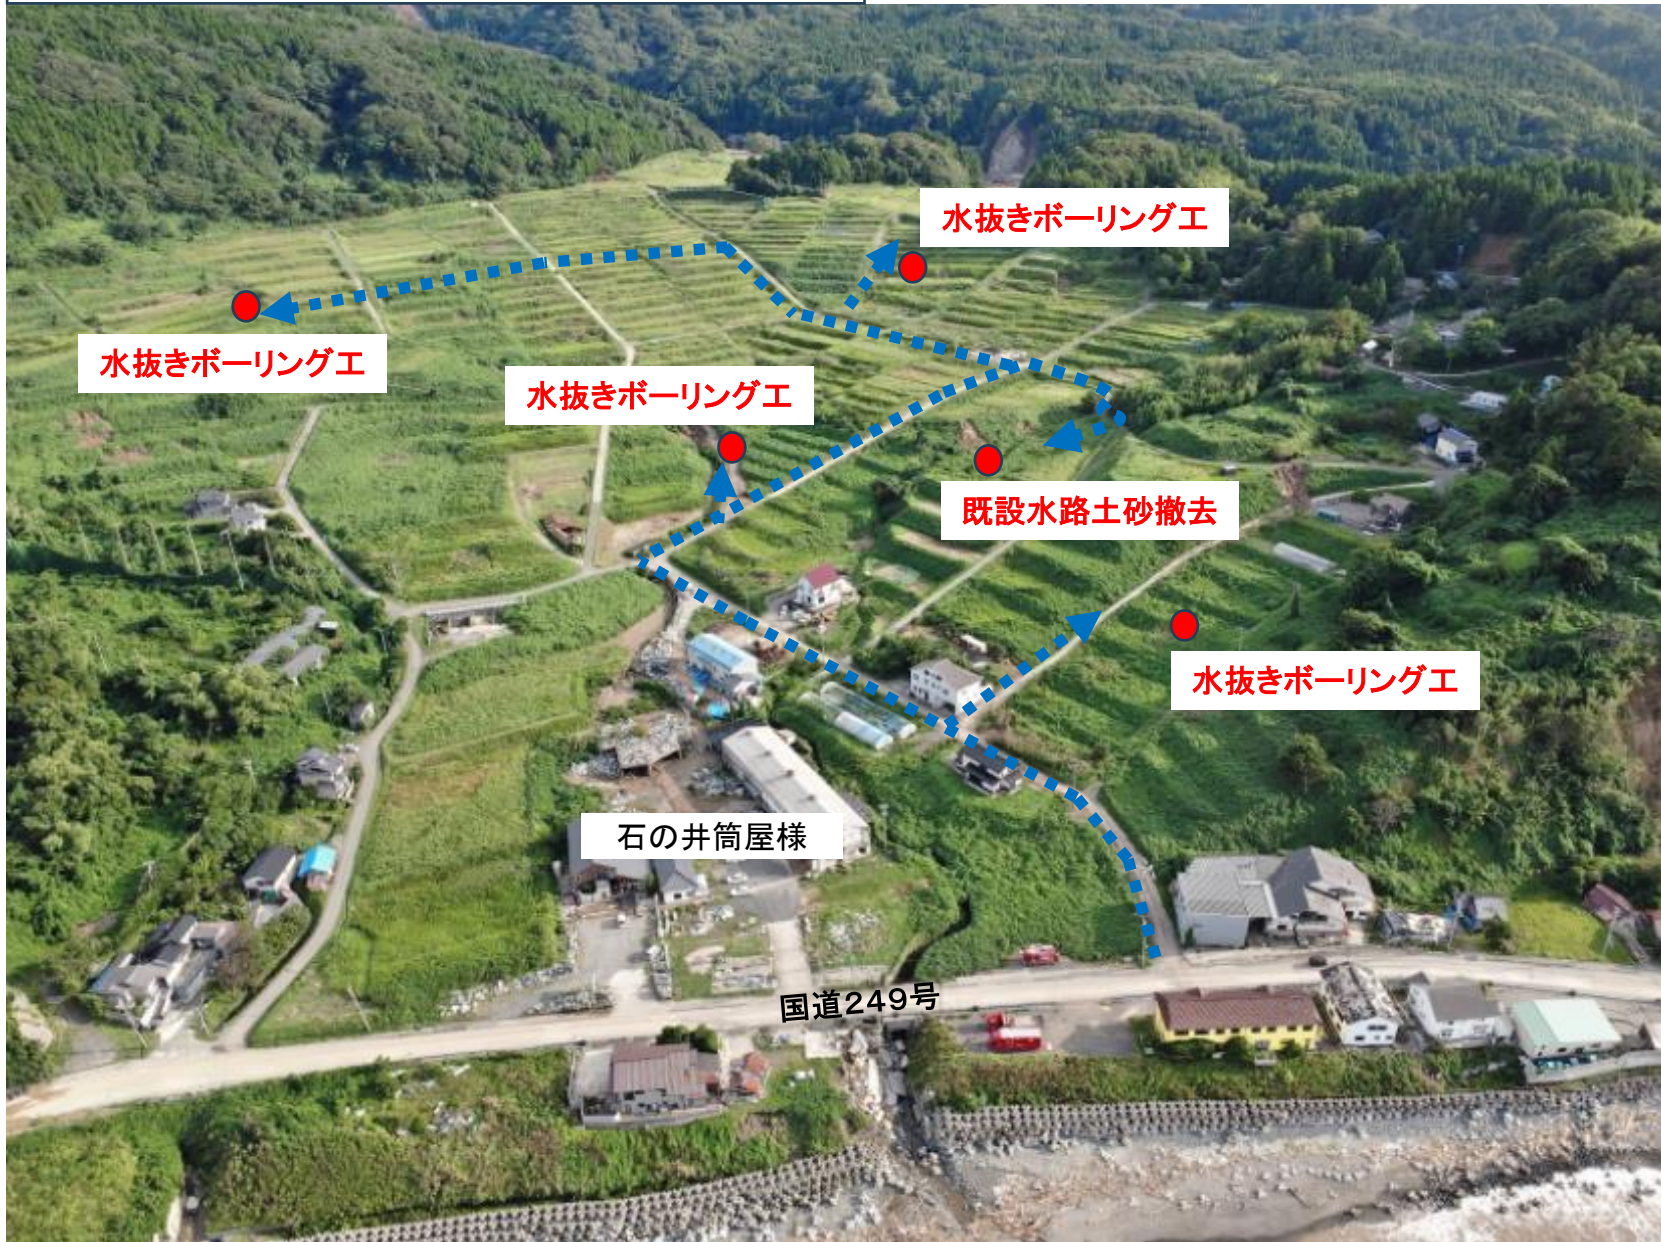
## 工事車両の進入路（東側）

## ..... 工事進入路

①農地側の水抜きボーリング工等は、既存の農道等を使用

②工事進入路の路線で、地震により通行が困難となっている箇所がある場合は、工事車両の通行が可能な仮復旧を行いつつ工事を実施
