特定災害復旧事業「石川農地海岸地区」

# 令和7年度 実施予定工事の概要

令和7年7月16日

農林水産省 北陸農政局

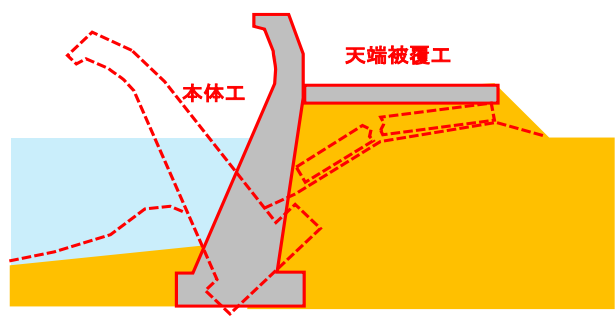
全面復旧(撤去・復旧)

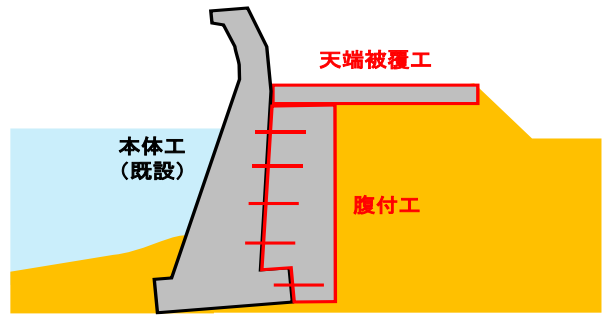
腹付工法(既設構造物を使用)

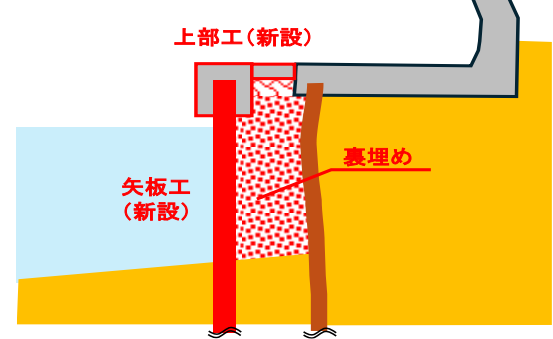
全面復旧(前出し新設)

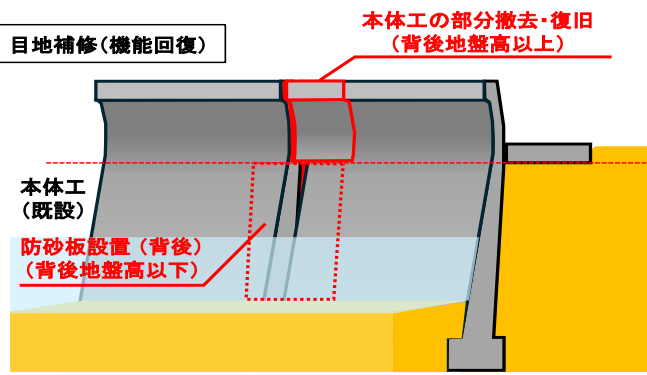
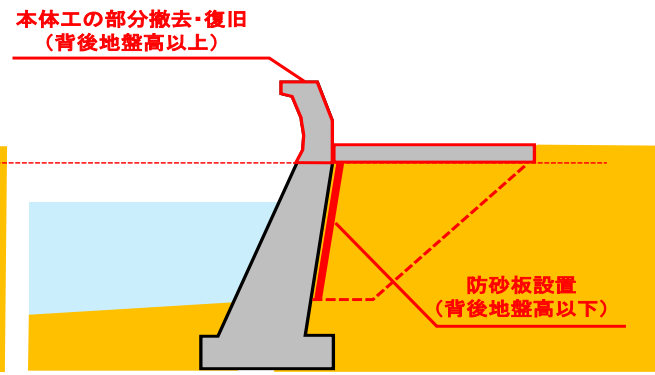
目地補修(機能回復)

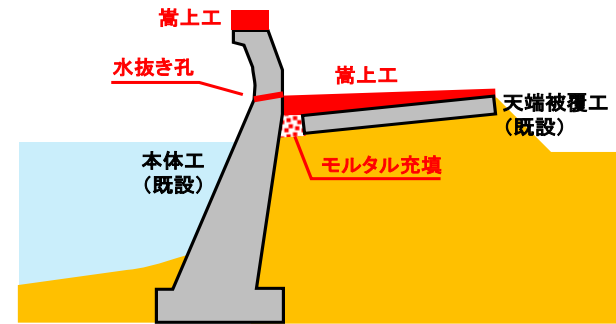
嵩上げ工法(既設構造物を使用) 水抜き孔の削孔  
モルタル充填(機能回復)

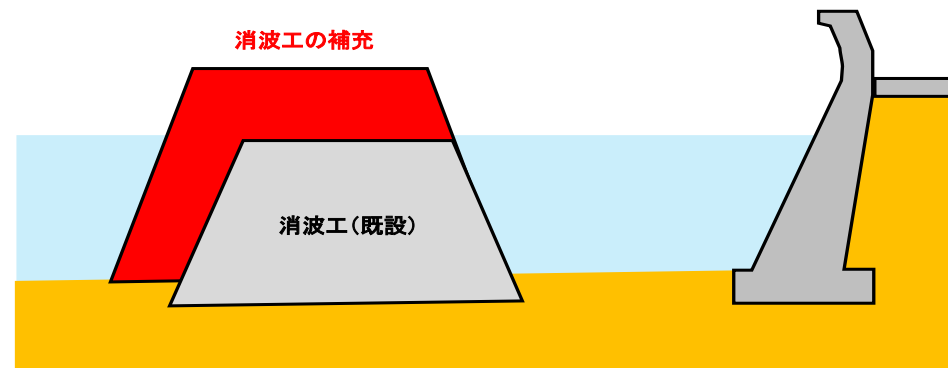
消波工の補充(消波断面の回復)

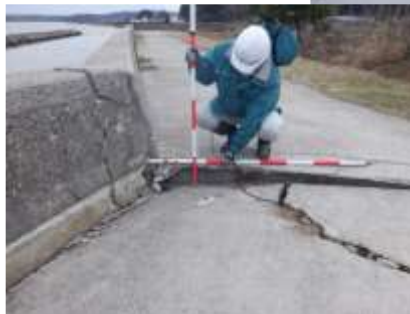
①堤防傾斜

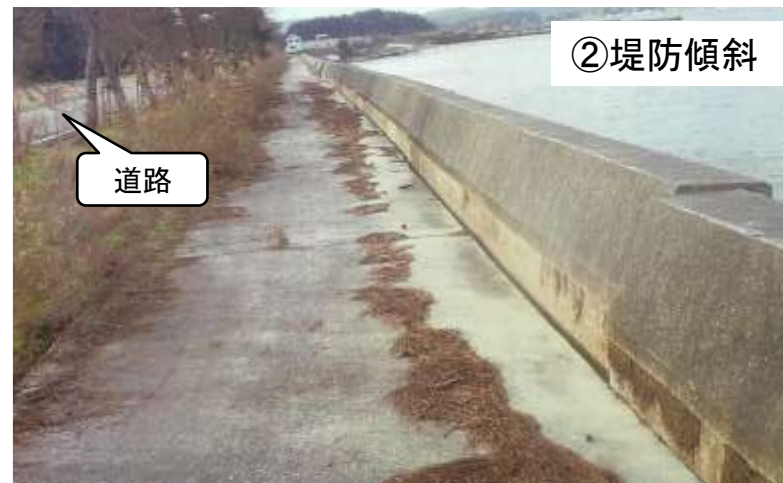
②堤防傾斜

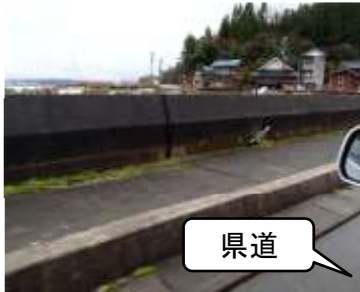
①堤防沈下

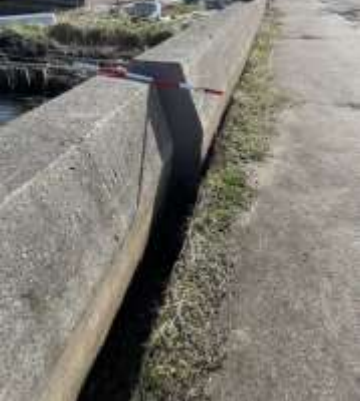
②堤防傾斜

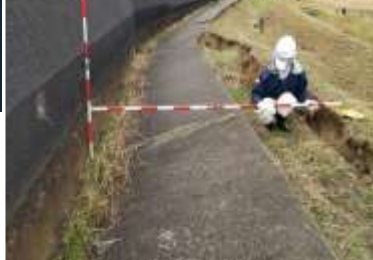
③堤防沈下

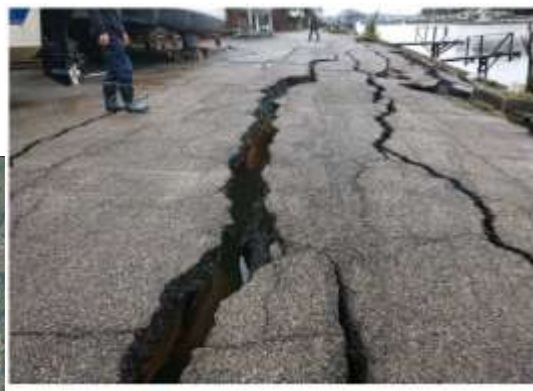
①天端道路ひび(住吉地区)

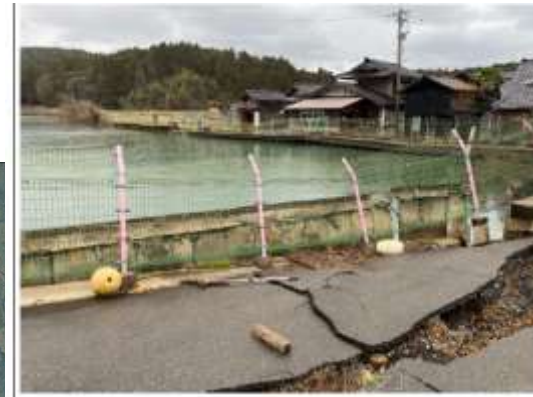
②護岸倒伏(甲地区)
